RAF CULMHEAD

Second Edition
Airfield Research Publishing for:
Somerset County Council
Taunton Deane Borough Council
Blackdown Hills AONB

1 Introduction

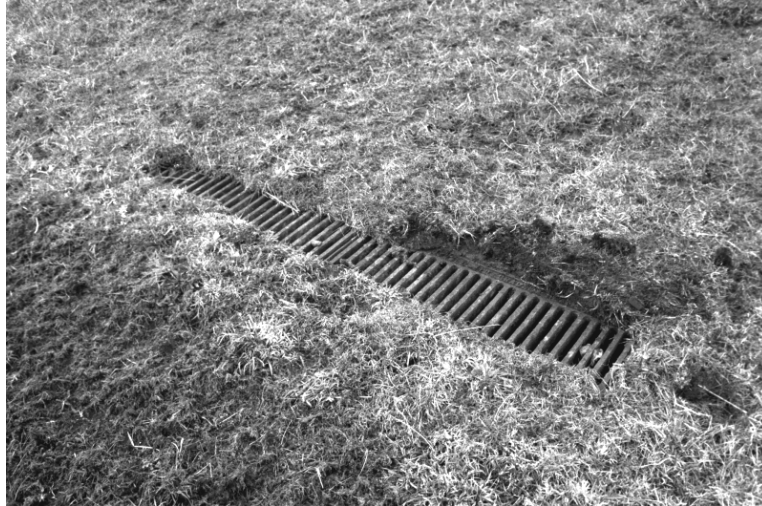
Figure 3: Cast-iron runway drain cover

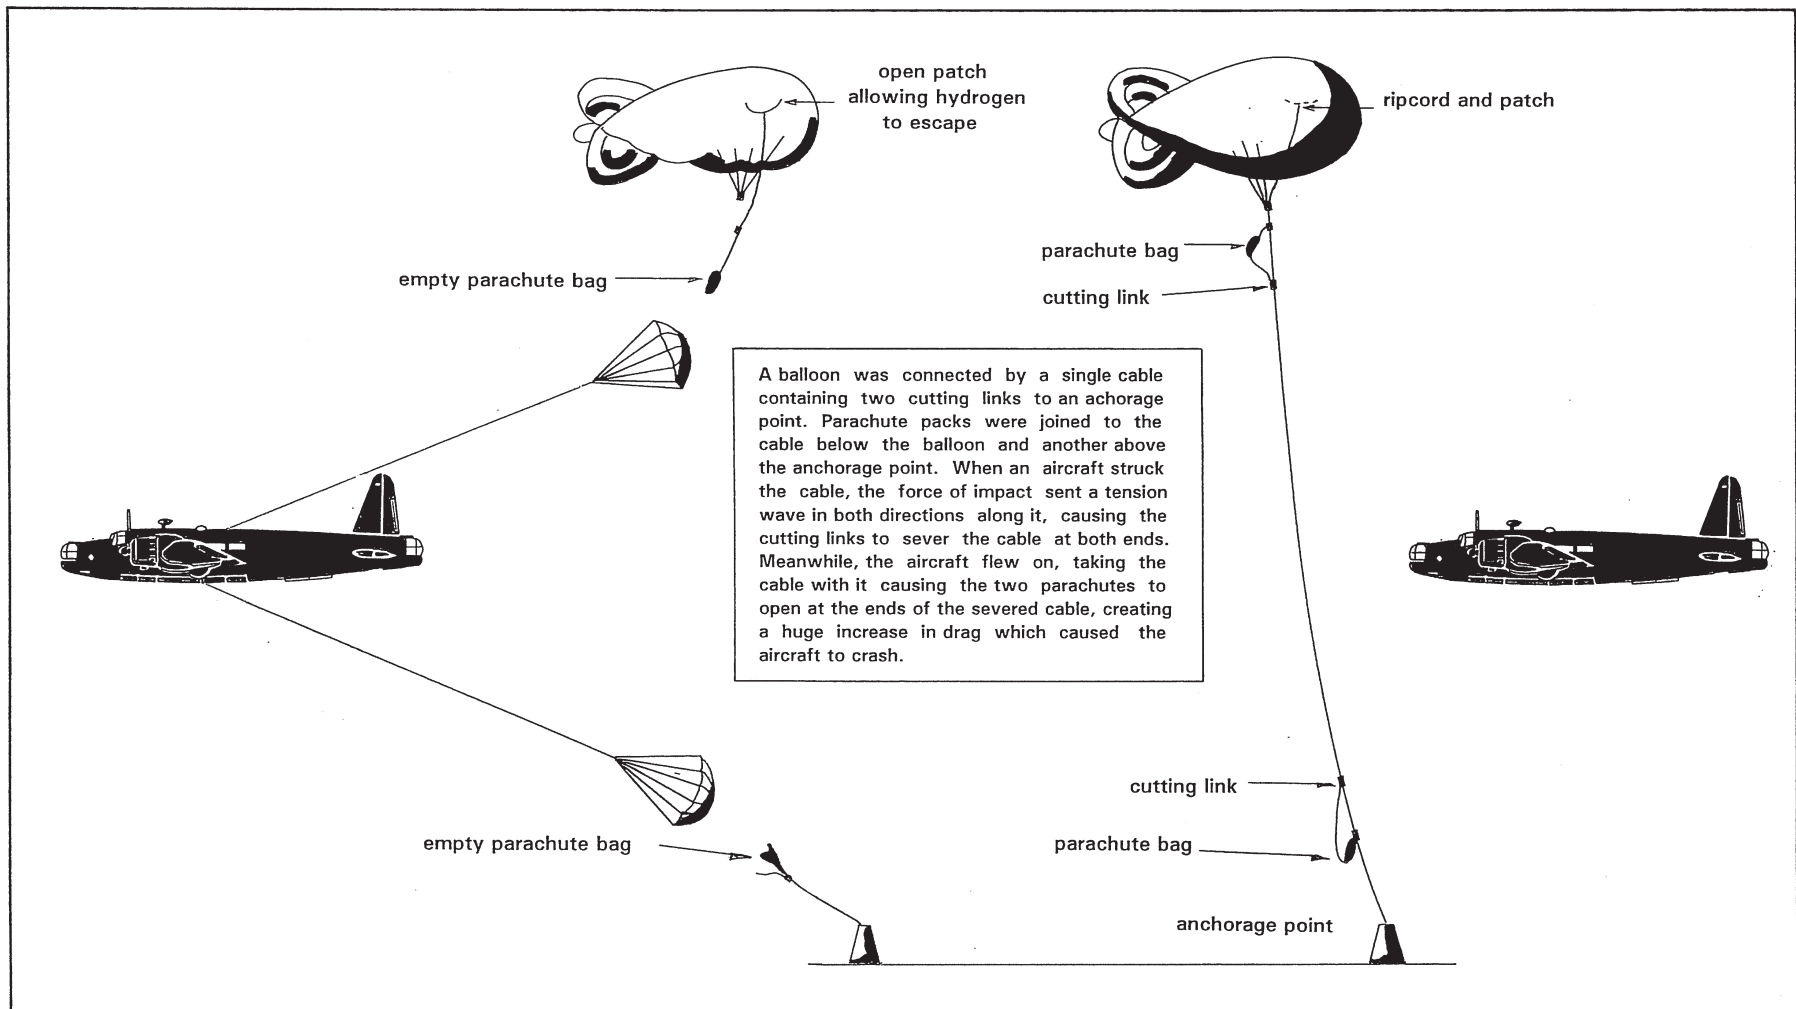
Figure 5: The Double Parachute Link system developed by the RAE at Pawlett Hams.

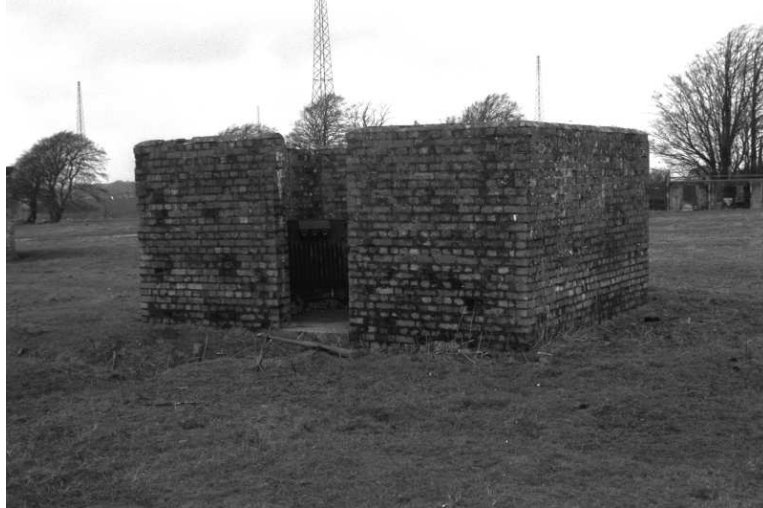
Comments: most are in good condition and some still have the remains of the distribution units inside the enclosure. Nearly all have had the blast wall knocked over.

Figure 10: Transformer plinth 538 (3).

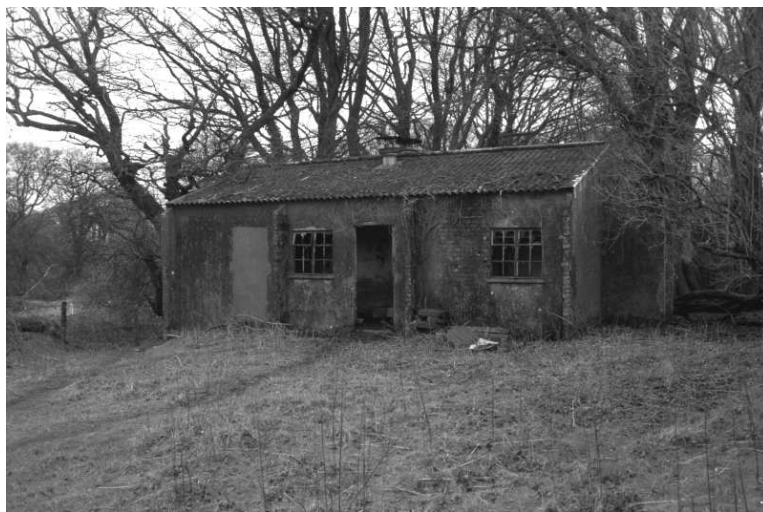
Comments: building 178 now has a corrugated iron roof and like building 201 has had a large opening inserted into an end wall. Building 198 is the only one still with its original entrance porch.

Figure 12: Latrine block to drawing 9026/41. 198 (8).

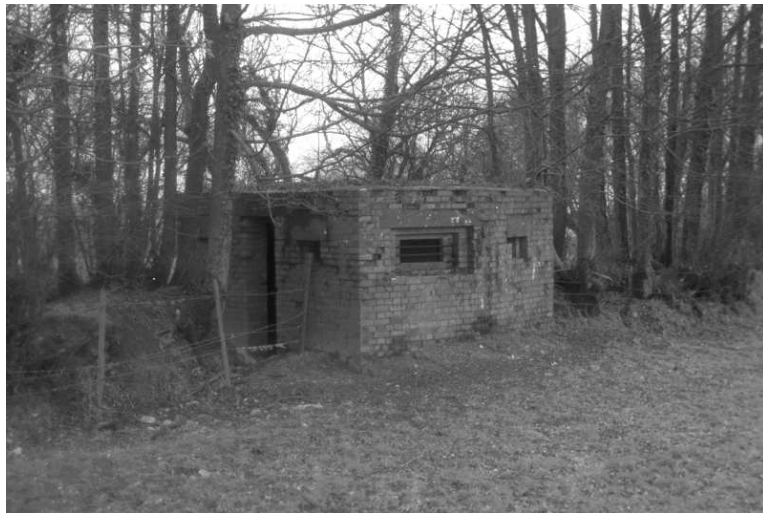
Figure 13: Pillbox. Note steel shutter fixed to large loophole. 518 (14)

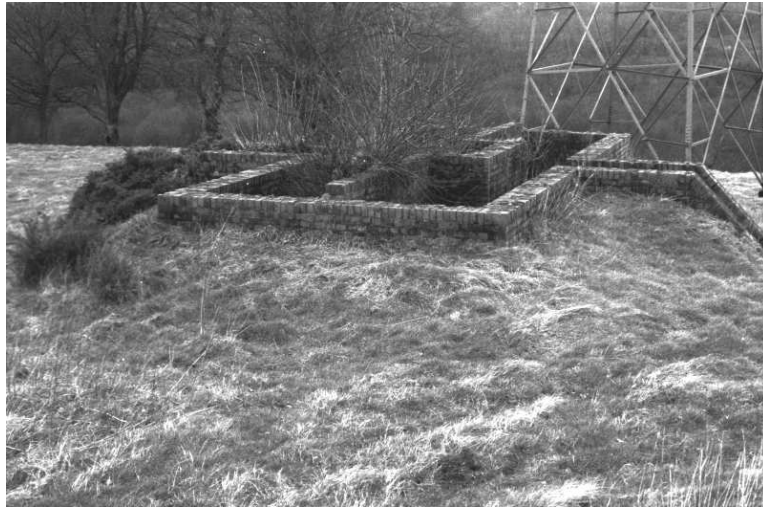
Figure 16: Blast shelter to drawing 2360/41. 503 (21)

Comments: all nine blast shelters are extant. Brick walls are in excellent condition but in most cases the earthwork traverses have been eroded away.

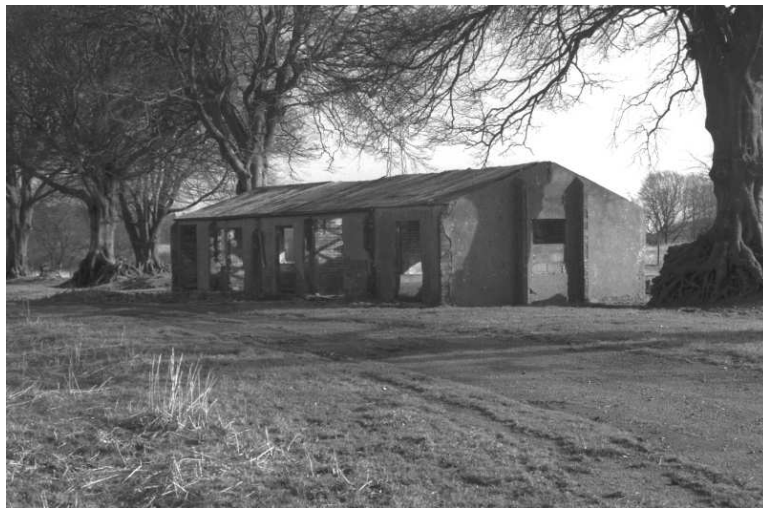
Comments: now in very poor condition with all doors and windows missing, the original roof has been replaced, but now even this has a large section missing.

Figure 17: Old Gas Clothing and Respirator Store 158 (27)

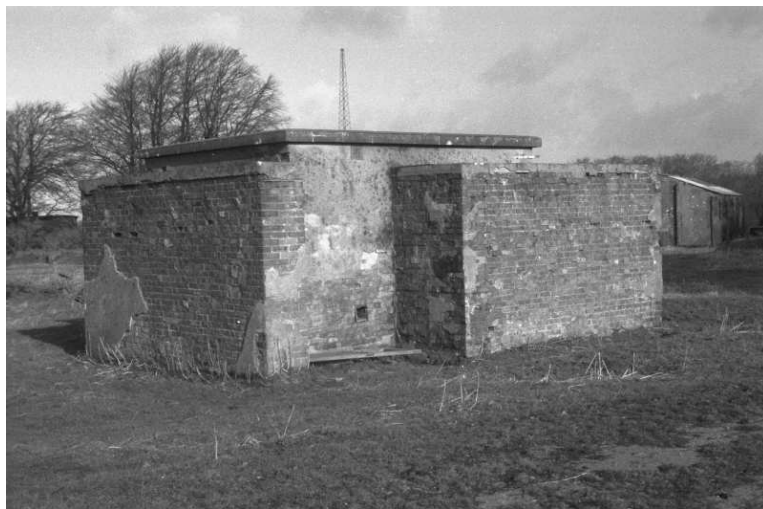
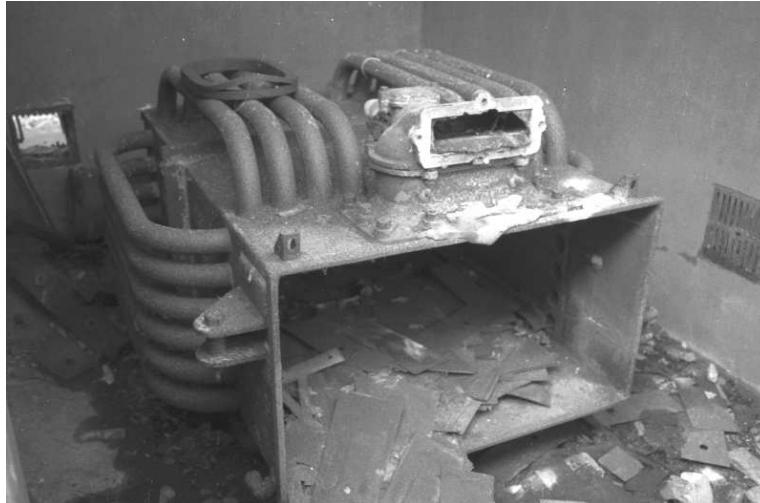
28–29. 6 and 6a: Main Inlet Electrical Sub-Station 12648/40 and 13455/40

Figure 18: Main inlet electrical sub-station to drawing 12648/40. 6 (28)

Figure 19: Transformer inside Main Inlet Electrical Sub-Station 6 (28)

Comments: both the building and enclosure are in good condition. Very interesting to see the transformers and distribution units extant.

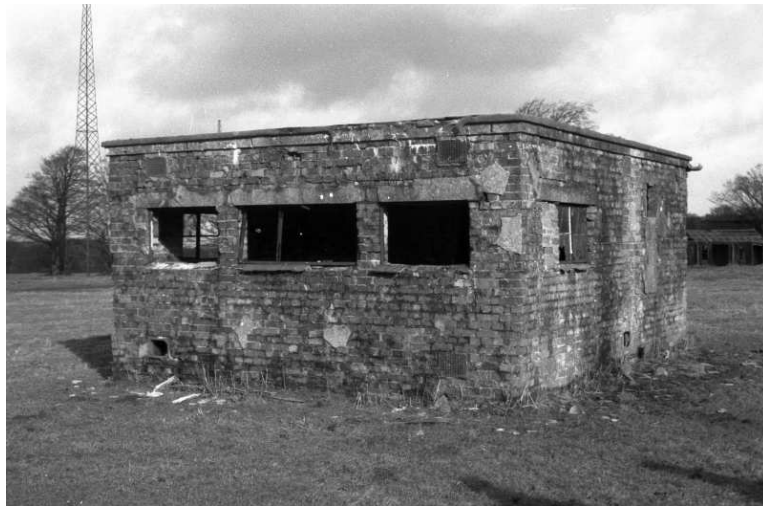
32. 1a: Battery Charging Room (Old Watch Office 14483/40)

Figure 21: Battery Charging Room (Old Watch Office) 1a (32)

Built as one of the original brick-built structures at Churchstanton, this was the watch office and its design is typical for that of an early satellite fighter station. The layout was very simple with a blast wall protected entrance leading to a gas-proof door. This gave access to a single room functioning as the watch office. Although the building only had one

Comments: the building survives in good condition and even has its original steel window frames. Out of 37 known examples built during WW2, twelve buildings are extant. Of these only eight (of which Culmhead is one) are in their original form without any further wartime extensions.

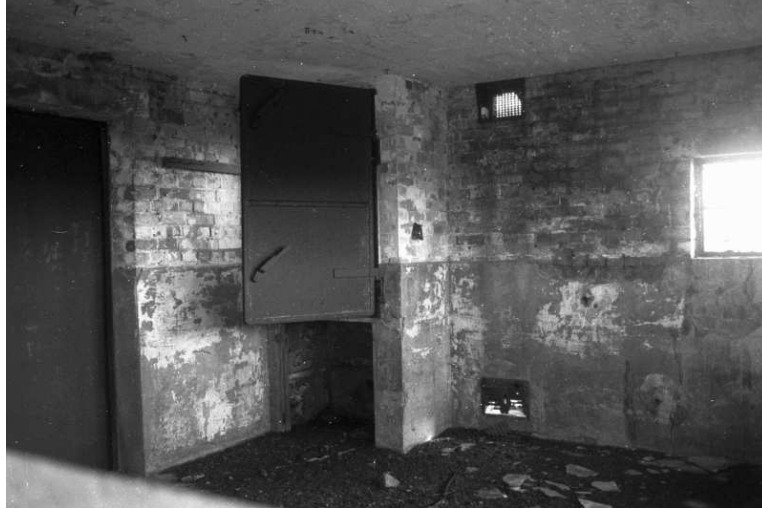
Figure 22: Interior view of Old Watch Office showing steel door of Pyro Cupboard. 1a (32)

room, a chemical closet was located between a side elevation and blastwall. Inside the watch office, in one corner, is a pyrotechnic cupboard, which today still retains its gas-proof steel door.

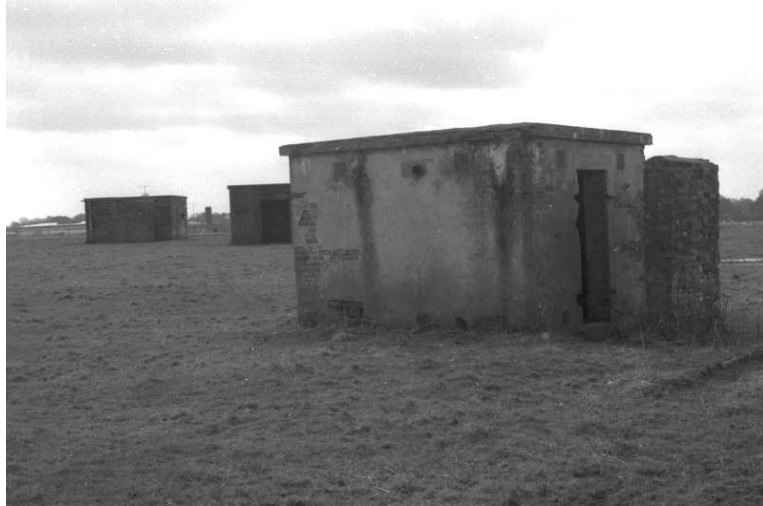
34. 8: Aviation Petrol Installation 9565/41

One aviation petrol installation was provided on the main technical site and another (8a) of a later design was dispersed out on the airfield. Both installations comprised four 12,000 gallon tanks (9 feet diameter and 33 feet long) positioned in pairs at a distance of 50 feet from the centre and either side of a pump house. Three concrete hardstandings were provided along a service road, two of these located adjacent to the buried tanks. These were for the use of petrol

Figure 23: Aviation Petrol Installation – Pump House 8 (32)

company tankers to park and off-load their contents. This was achieved through a five-point steel manifold with 4-inch diameter pipes connecting with the pair of tanks. The third (and central) hardstanding located adjacent to the pump house was for the use of the RAF tanker. A hose from a steel standpost located at the centre of the pump house blast wall (on the front elevation) was connected so that the tanker could be filled up with fuel. Having completed this task the tanker driver then drove out to the aircraft awaiting out on dispersal to off load.

Comments: while the pipes do not survive, evidence can be found where the 4-inch diameter suction (lower) and delivery (higher) pipes entered and left the pump house. It is not known whether the petrol tanks are extant or not.

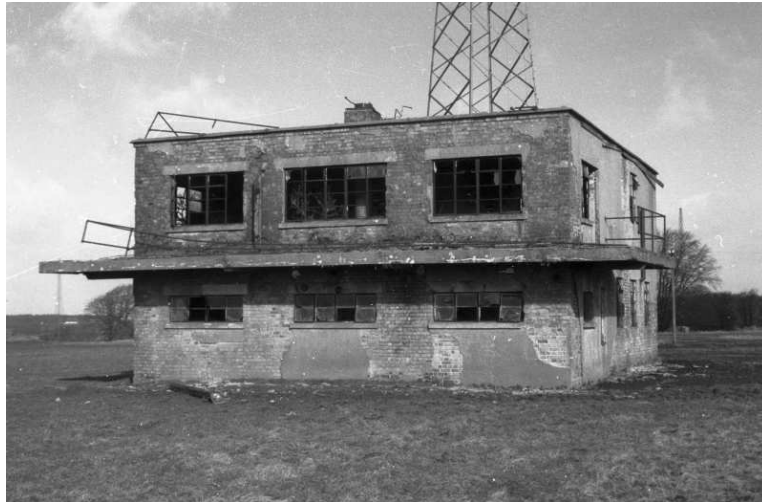
Figure 25: Watch Office (Control Tower) to drawing 343/43. 16 (35)

Comments: a total of 164 buildings of this type were built on 164 airfields. Today only 68 are extant including examples at Dunkeswell, Upottery and Westonzoyland. Preservation of the building at Culmhead would be possible and the following observations have been noted:

- The greatest problem to be overcome will be making good, the damage to the roof and first floor. Large holes have been cut through exposing the hollow Seigwart reinforced concrete beams and rain has resulted in serious corrosion of the steel reinforcing rods.

- The basic exterior fabric remains sound although much of the cement rendering has fallen off.
- All original steel windows are extant and much of the tubular railings remain but, these are not fixed to the concrete roof and balcony. The steel stair connecting the balcony to the roof is extant but the treads have corroded away.
- It is interesting to see the obstruction light fitting still attached to its post, but now lying on the ground (Figure 26).
- The original interior paint colour scheme is still evident with green to dado height with cream above.
- No evidence was found inside the watch office and control rooms of earlier larger window frames suggesting that the building was constructed after 1943 to drawing number 343/43.

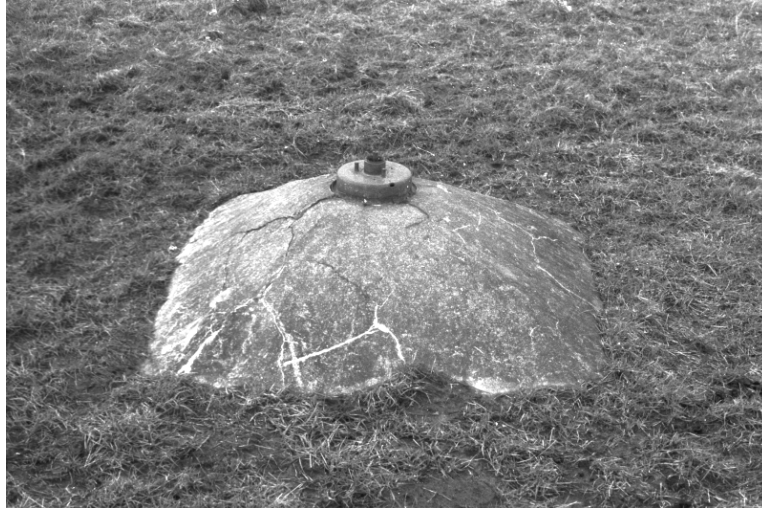
Figure 27: Signals Mast Fixing Block

This is a concrete block for supporting a signals mast. The signals mast is a vertical mast for displaying a system of signals to advise pilots on the ground of the current operating conditions on the airfield.

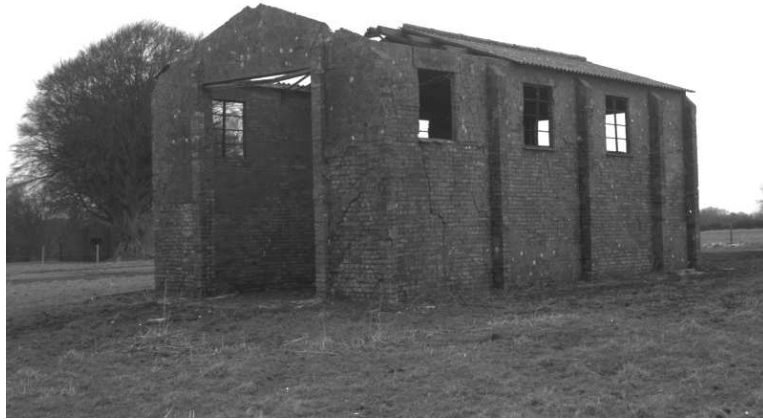
Figure 28: Floodlight Tractor and Trailer Shed to drawing 12411/41. 17 (37)

Comments: today this building is in poor condition, a structural failure of a side wall has occurred and part of the roof sheeting is missing.

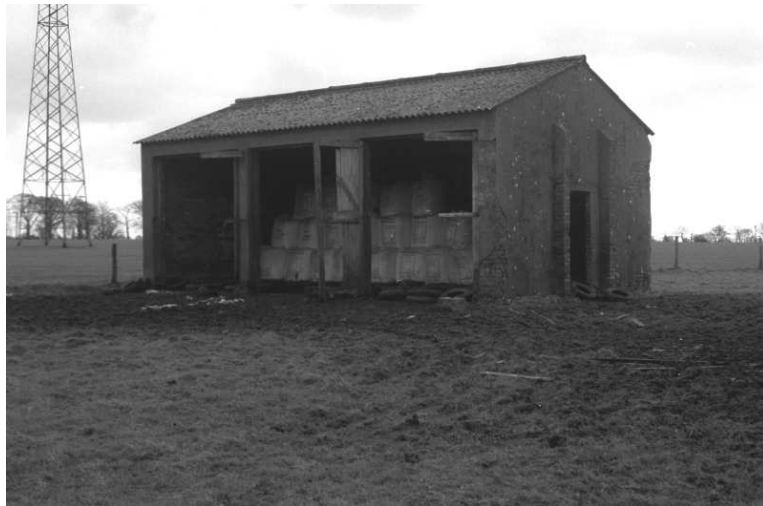
Figure 29: Night Flying Equipment Store to drawing 12411/41. 29 (38)

Comments: the NFE store is in good condition with original roof still in place. Now used as a farm store.
Current Status: appears to survive on aerial photographs taken in 2001.

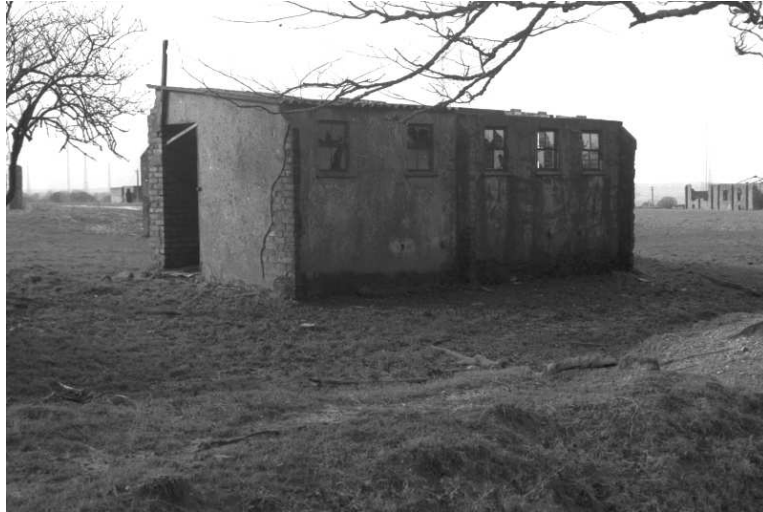
43–45. 5a, 5b, 31: Technical Latrines 9026/41

Figure 30: Technical Latrine block to drawing 9026/41. 5b (44).

This design is the smaller version of the two types of latrine blocks found on drawing number 9026/41. It is also the most common version found on RAF stations, typically they were called either RAF or WAAF technical latrines when used by ground crew (technical trades such as engines, riggers or instruments etc) who were working in workshops, stores or on actual aircraft. Alternatively they were simply referred to as either RAF latrines or WAAF latrines when located on domestic sites. Normally buildings were divided into two sections, one for officers and the other for other ranks.

Comments: all are in good condition.

Current Status: 44 appears to have been destroyed on aerial photographs taken in 2001 but the others appear to survive.

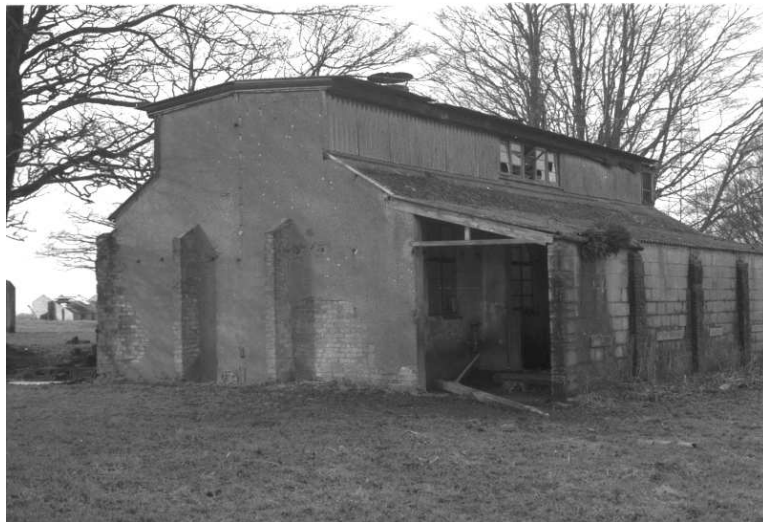
46. 30: Parachute Store 11137/41

Figure 31: Parachute Store to drawing 11137/41. 30 (46).

Comments: the building is in good condition complete with window glazing and has been extended with a temporary arrangement of breeze blocks and a single pitch roof. In this form it is still in use by the farmer.

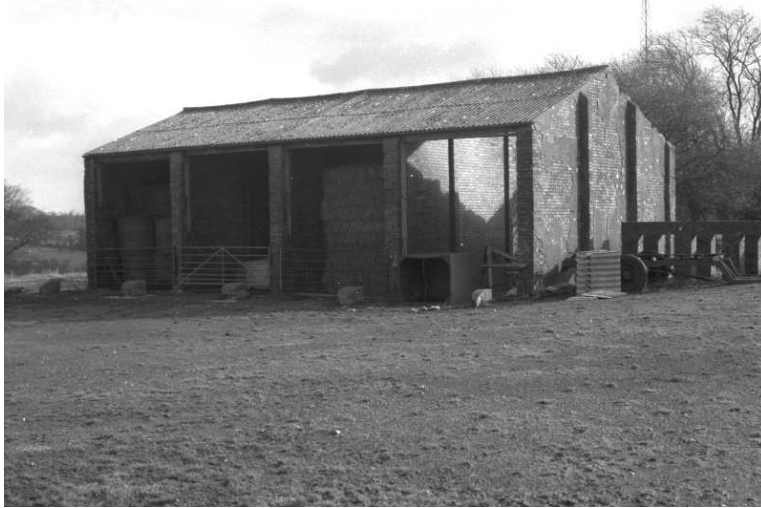
Figure 32: MT Vehicle Shed and Yard to drawing 12775/41. 25 (27)

Comments: the Nissen hut has been removed but, the vehicle shed and inspection ramp survive in good condition.

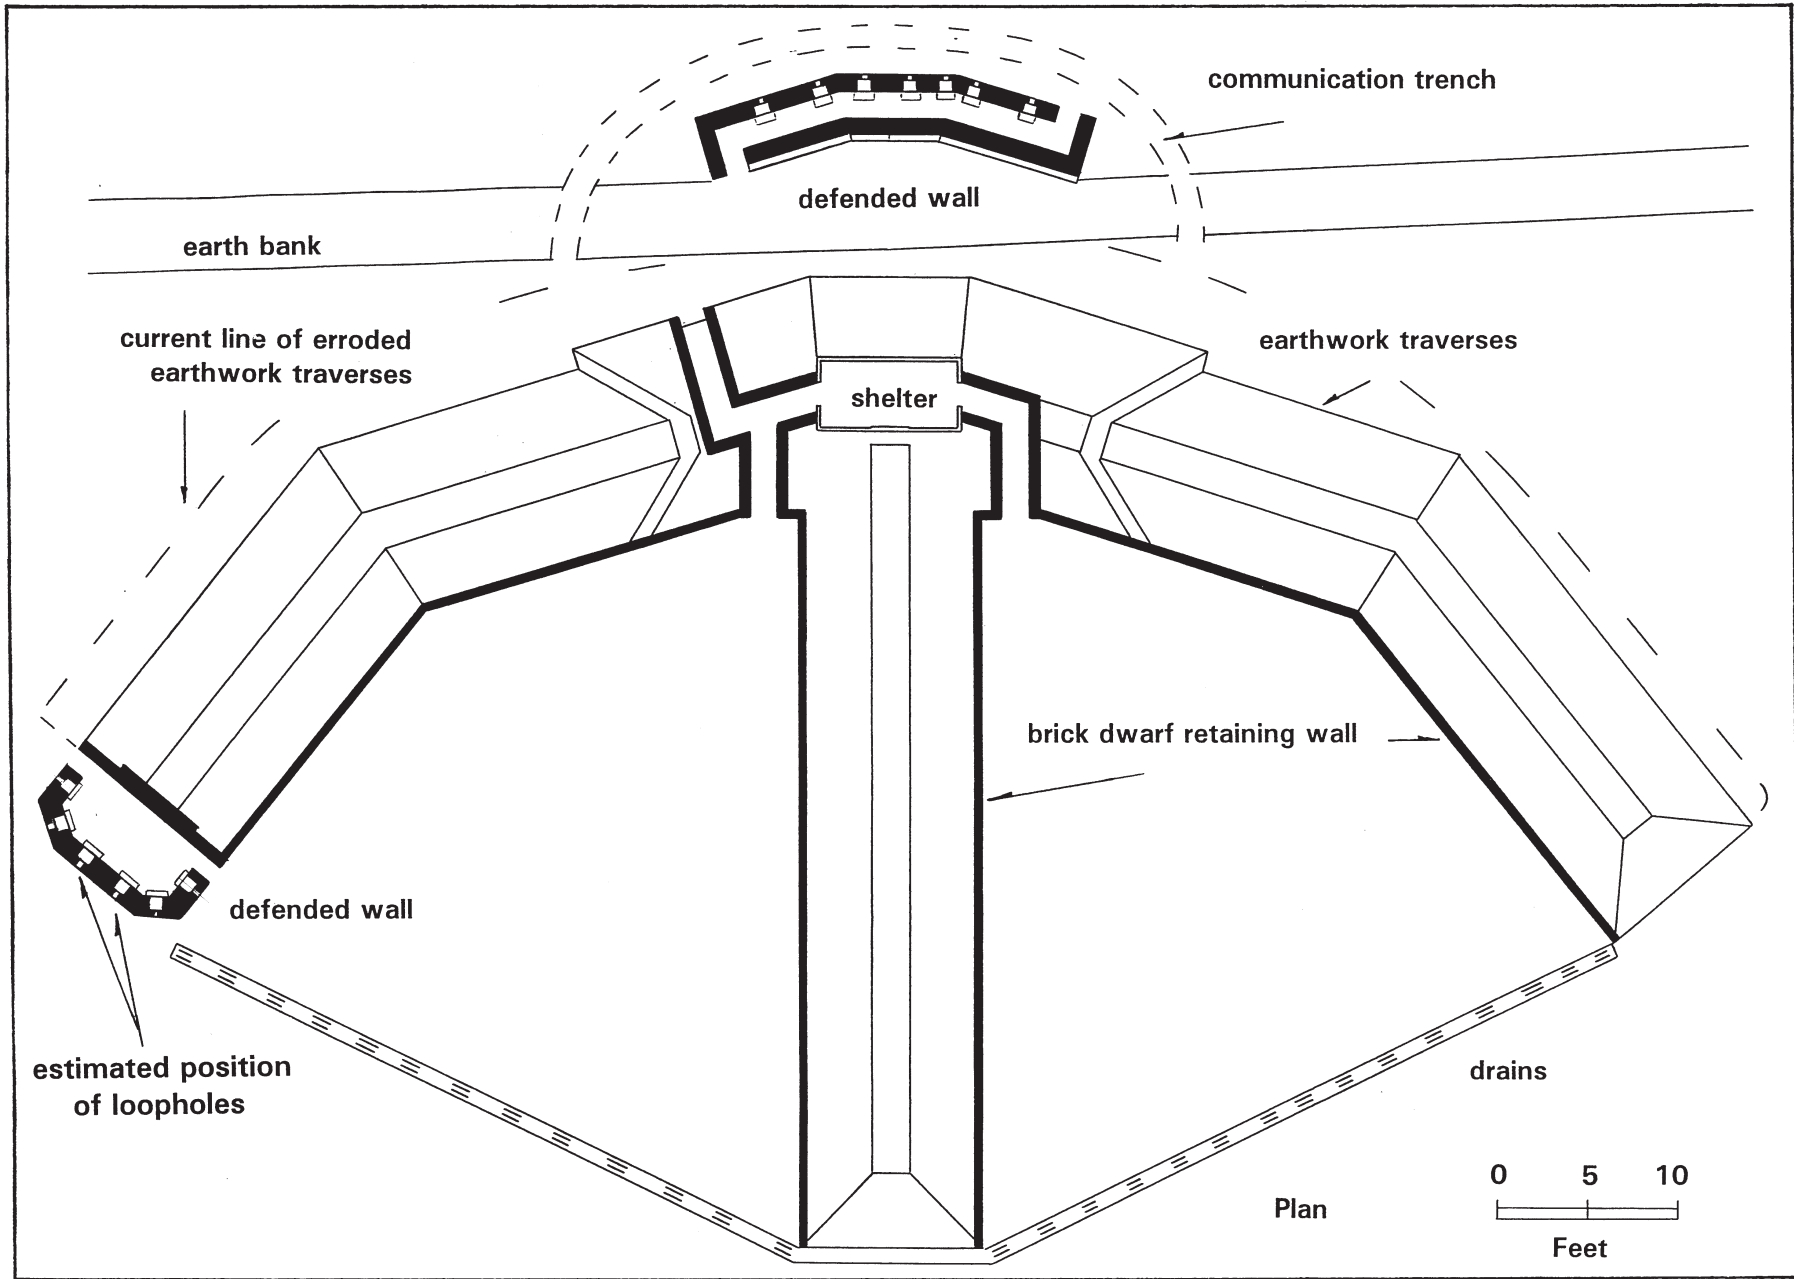
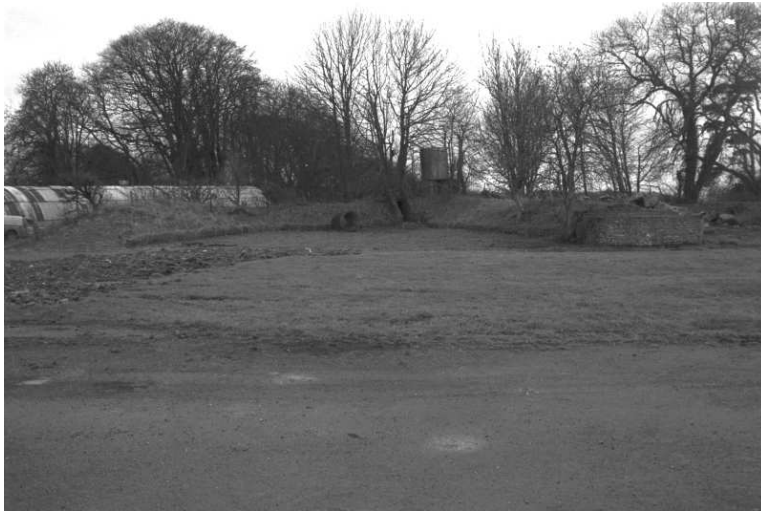
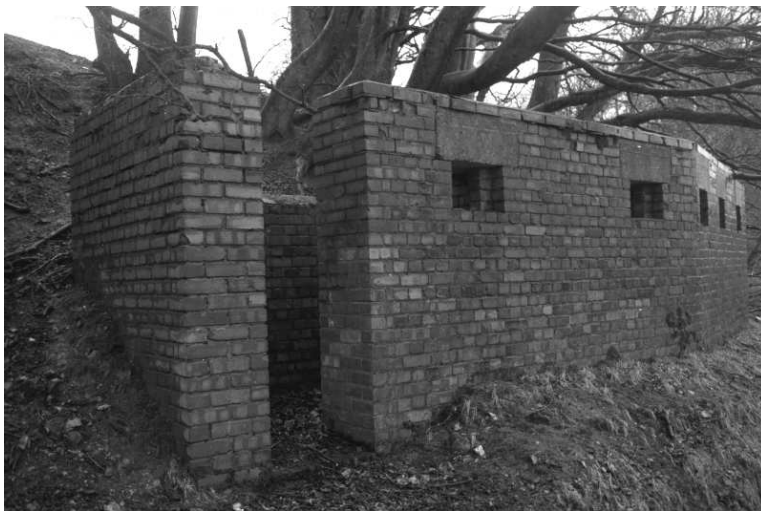
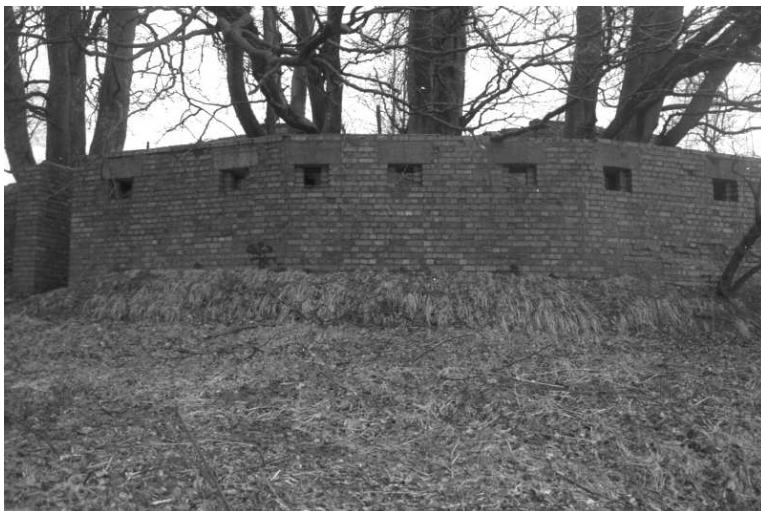
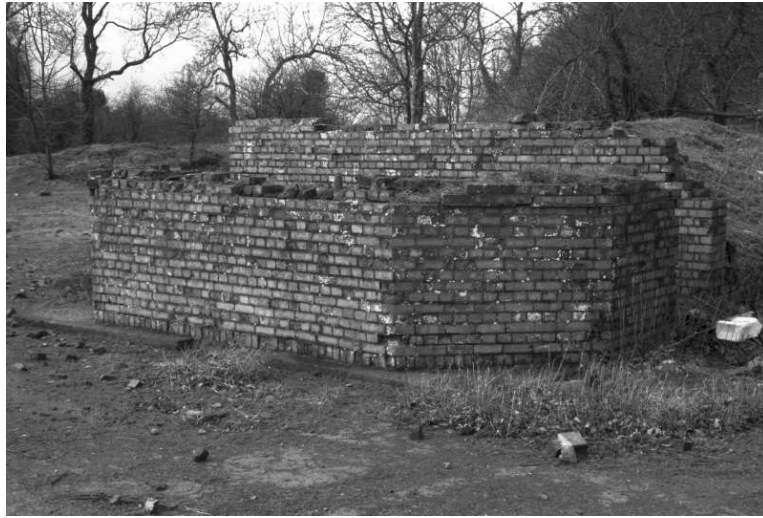
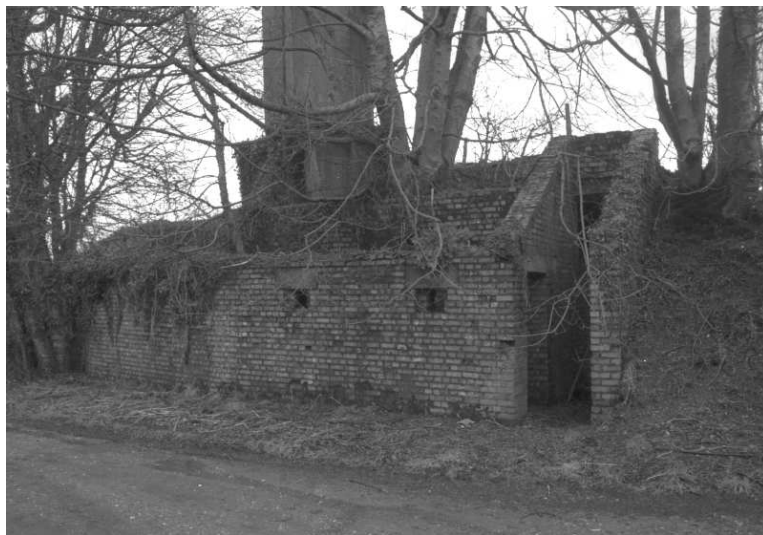
Figure 35: Dispersal pens for fighter aircraft type "B"FCW 4513. Plan showing defence positions of pen 226.

Figure 36: Aircraft Fighter Pen to drawing FCW 4513. 229 (57)

Figure 37: Angled Defended Wall at the rear of Pen 226 (54)

Figure 38: Angled Defended Wall at the rear of Pen 226 (54)

Figure 39: "U"-shaped Defended Wall at the front of pen 228 (56)

Figure 40: Angled Defended Wall at the rear of Pen 229 (57) and exit from air-raid shelter

Comments: In all cases the earth traverse walls have been eroded, although enough of the original shape has been retained to recognise its original shape. The dwarf brick wall and the concrete drains are extant and are all in good condition. The angled and straight defended walls are also in excellent condition but, the “U”-shaped walls have lost some courses of brickwork including the loopholes. The Stanton air-raid shelters are all in excellent condition.

- On rarity alone, the preservation of the pens must be the way forward. Steps should therefore be taken to ensure that no further soil erosion takes place. The eroded earthwork traverses could easily be repaired and landscaped to their original height and shape.
- It is essential that full measured surveys be carried out as soon as possible on all fighter pens, trenches and defended walls. This would allow a wider understanding of the airfield defences at Culmhead.

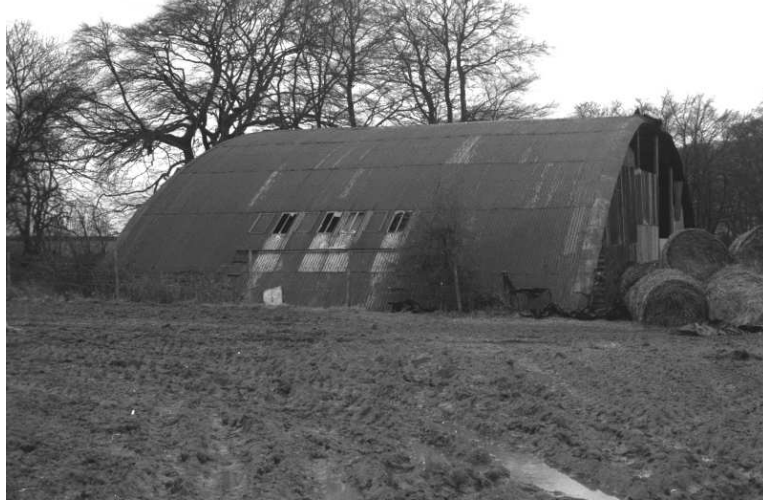
Comments: still in good condition and is now used as a barn.

Current Status: included in the area protected as a Scheduled Monument.

Figure 42: Blister Hanger to drawing 12512/41. 214 (63)

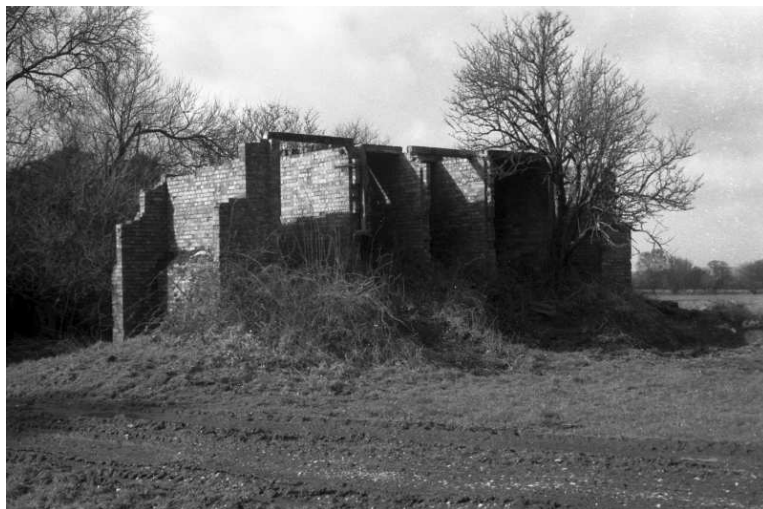
64. 28: Aircraft Machine-Gun Test Butt 16461/41

Figure 43: Aircraft Machine-Gun Test Butt to drawing 16461/41. 28 (64)

Comments: in good condition

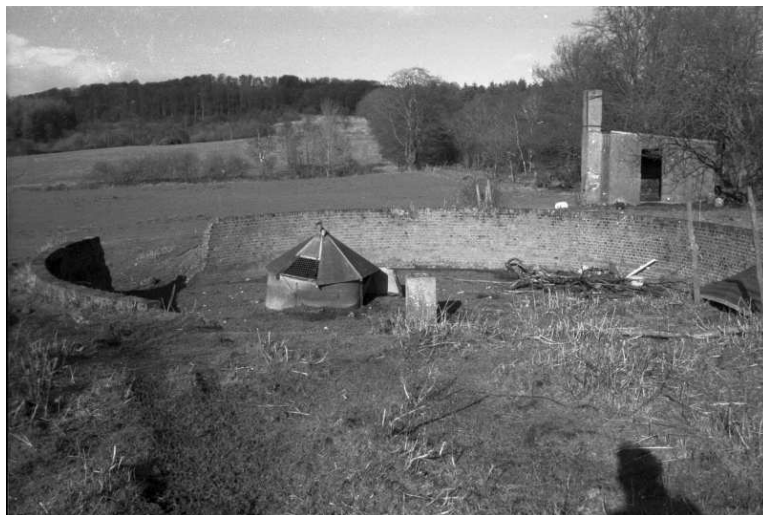
70–71. 161: Septic (Sedimentation) and Percolating Tanks

Figure 49: Septic Tank and Destructor House on the Sewage Disposal Site.

Comments: the brick tanks survive in good condition although the walls of both tanks have been breached. The concrete support for the rotating spray is extant. The brick-lined humus tanks are thought to survive but are now filled in and grassed over.

This is a small building containing a refuse bin, coal store and an incinerator (destructor) for the burning of combustible waste.

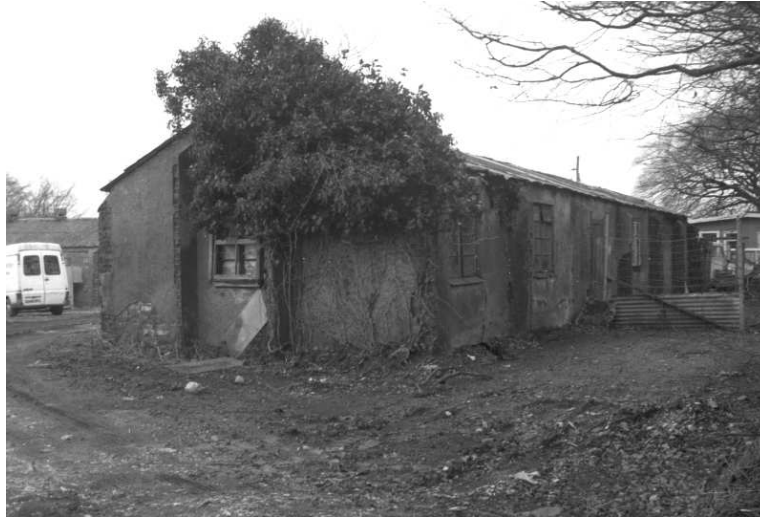
Figure 50: Commanding Officer's Quarters to drawing 9023/41 on RAF Communal Site. 53 (77)

Construction: cement rendered 13.5-inch brick walls supporting "Seigwart" type hollow reinforced concrete beams.

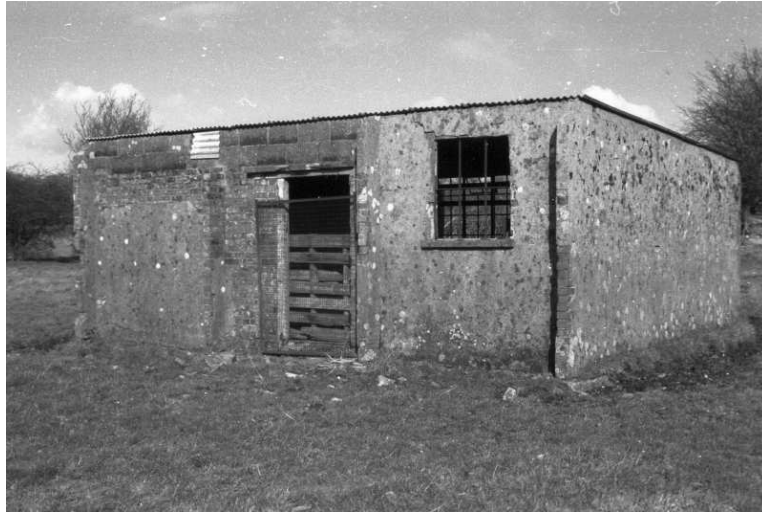
Figure 51: Officers' Ablution and Latrine Block to drawing 16330/41 on RAF Site 1. 61a (88)

Comments: now in poor condition.
